# **VOLUMETRIC WEAR ANALYSIS OF HIP JOINT IMPLANTS BY OPTICAL METHODS**

Dissertation Thesis

Brno 2018

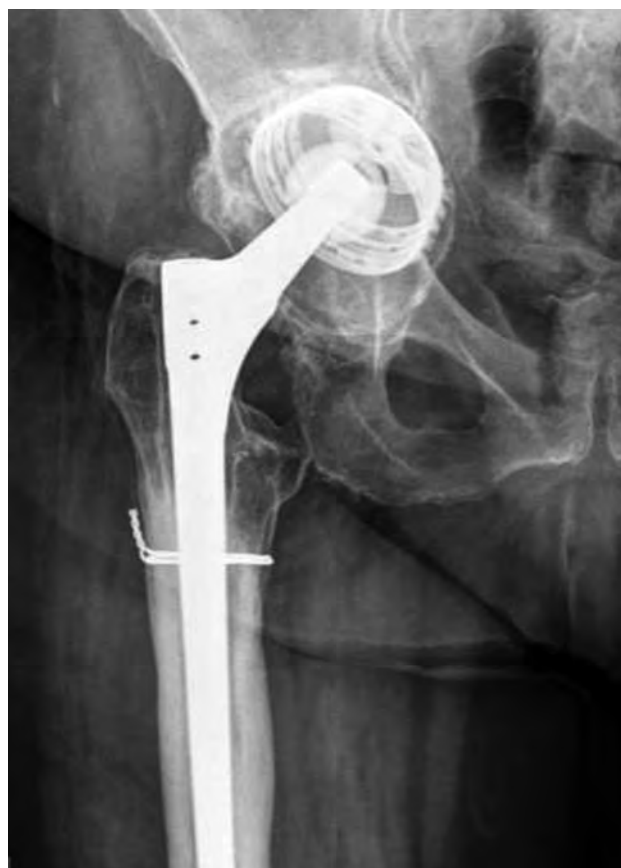
Obr. 1. Aseptické uvolnění jamky Bicon.
